RENODRY USA – RISING DAMP REPORT

Brookings County Courthouse

Rising Damp Report

ON FEBRUARY 26, 2019, TECHNICIANS FROM RENODRY USA CONDUCTED A VISUAL INSPECTION AND MASONRY CONDUCTIVITY TEST IN THE BASEMENT AND LOWER LEVEL AREAS OF BROOKINGS COUNTY COURTHOUSE IN BROOKINGS, SOUTH DAKOTA.

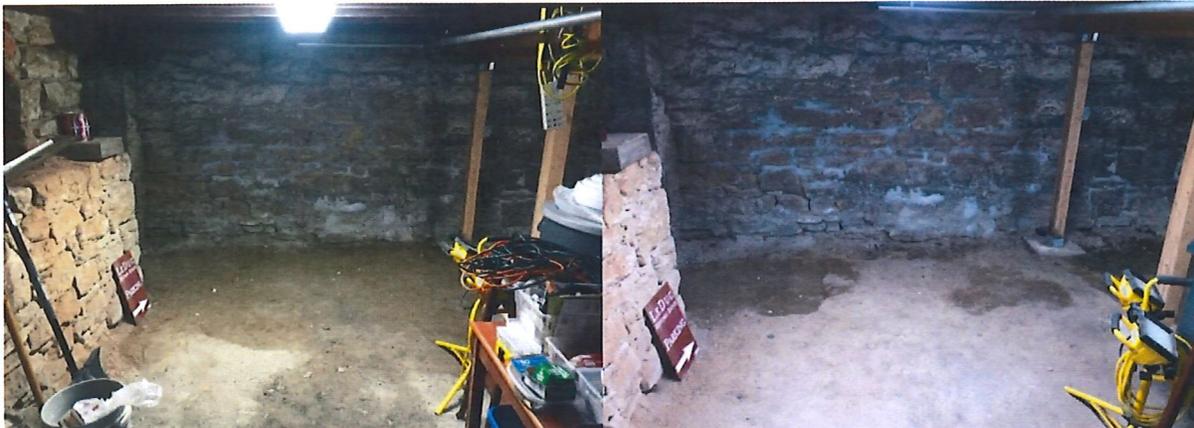
Civil War Era Historic Estate – Hastings, MN

Before

After Only 3 Months

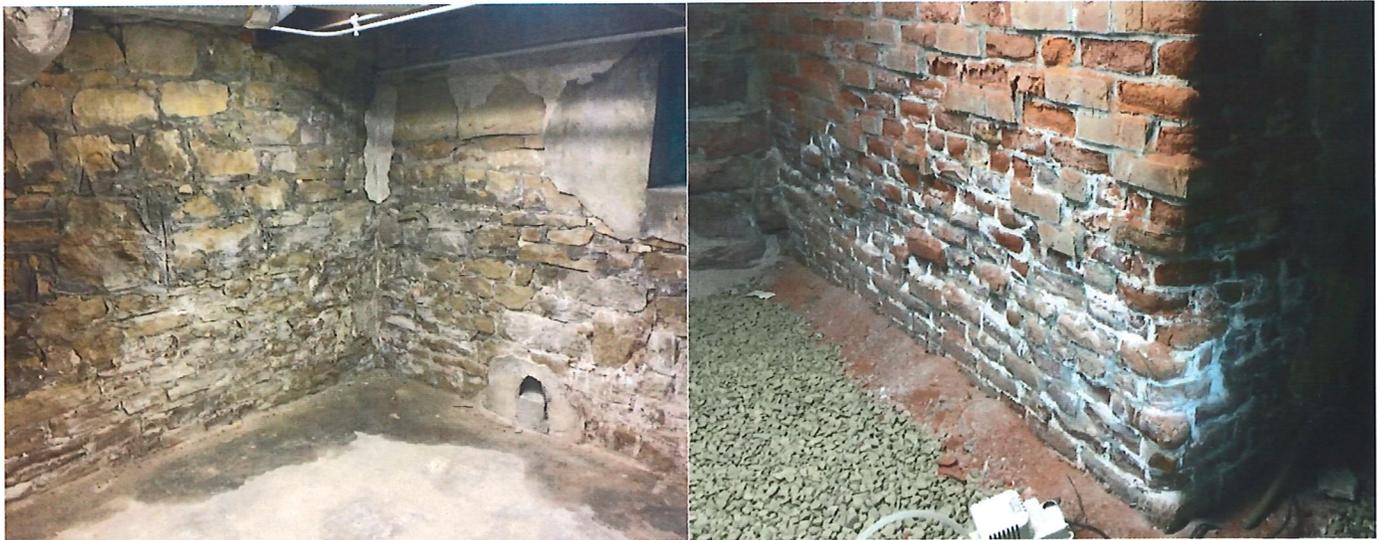
Signs of rising damp: Salt Efflorescence - Spalling Bricks - Wet Spots - Disintegrating Masonry
Musty Smells - High Humidity - Bubbling Plaster and Paint - Mold - Discoloration - Mortar Decay

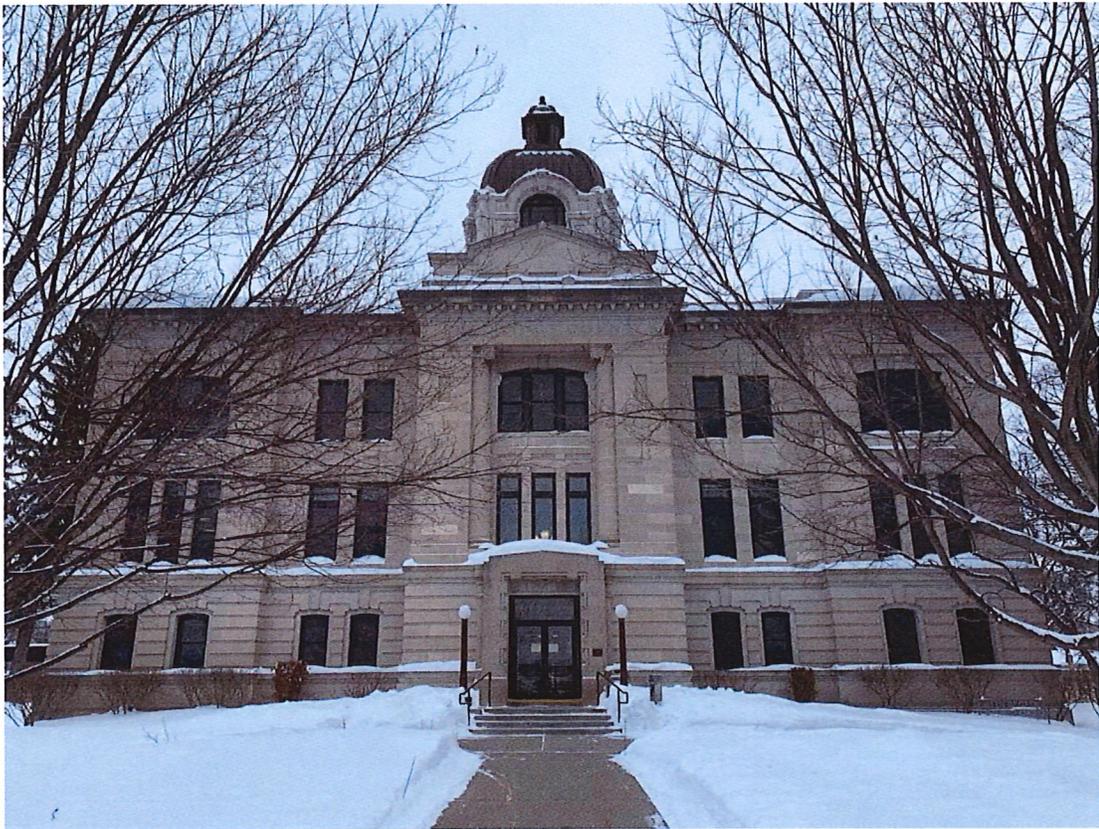
RENODRY BUILDING INSPECTORS DISCOVERED A RAPIDLY ADVANCING CASE OF RISING DAMP IN THE COUNTY COURTHOUSE. RISING DAMP IS WATER'S NATURAL TENDENCY TO RISE IN MASONRY. IT DESTROYS THE MASONRY FOUNDATION OF A BUILDING.

BUILT IN 1913, THE VERY FOUNDATION OF THIS 106 YEAR OLD COURTHOUSE BUILDING, WHICH IS ON THE NATIONAL REGISTER OF HISTORIC PLACES, IS BEING SERIOUSLY UNDERMINED. THIS REPORT WILL DEMONSTRATE THE PRELIMINARY EVIDENCE AS DISCOVERED DURING THE INSPECTION.

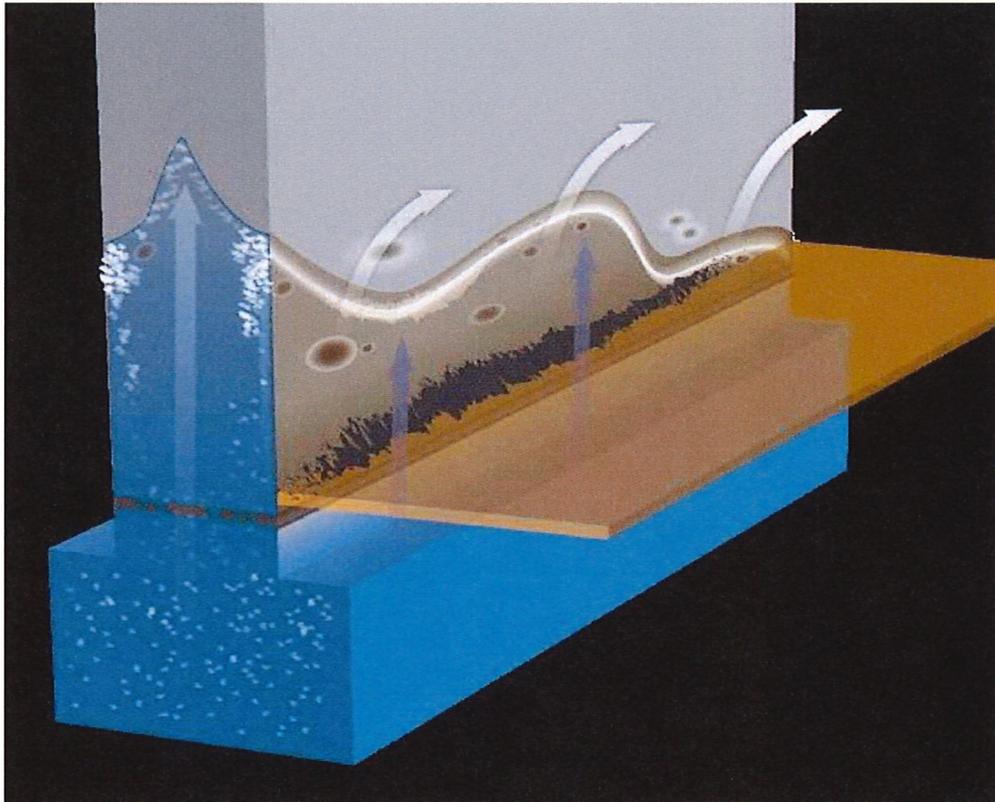
THE FOLLOWING DIAGRAM OF A WALL CROSS-SECTION ILLUSTRATES SEVERAL EROSION INDICATORS IN THE PRESENCE OF RISING DAMP (THE DAMPNESS AND SALTS THAT MOVE UPWARDS INSIDE THE WALL, FROM THE FOUNDATION, AFFECTING THE CORE OF THE MASONRY).

RISING DAMP IS A COMBINED PROBLEM OF DAMPNESS AND SALTS AFFECTING THE MASONRY AT DEPTH.

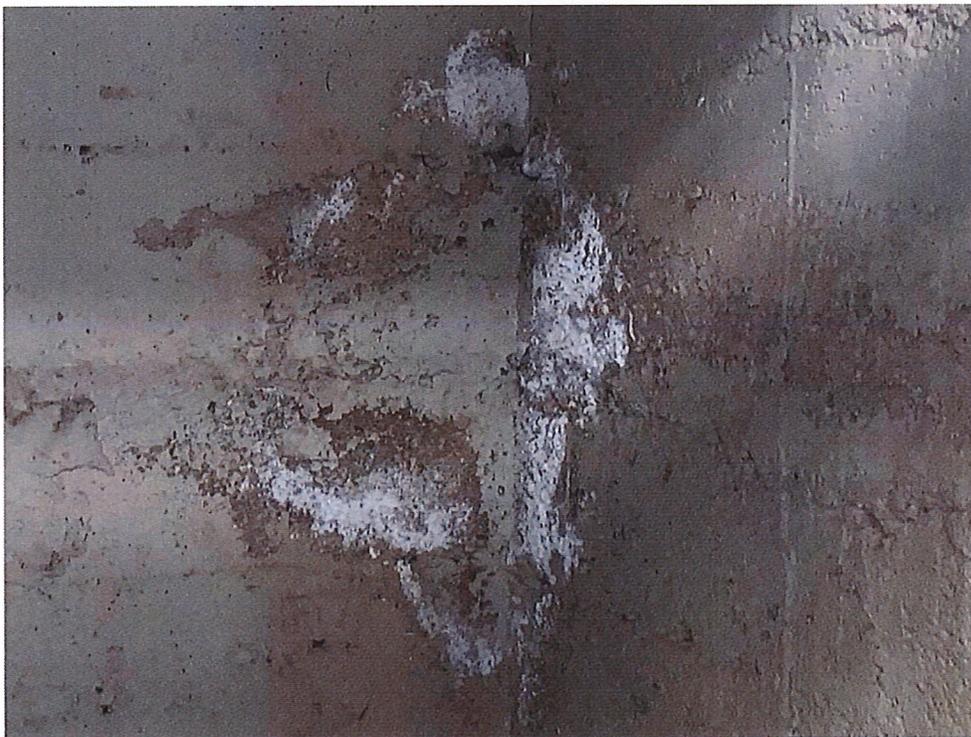
SALT DAMAGE: SALT NEST PUSHING THROUGH WALL IN COURTHOUSE

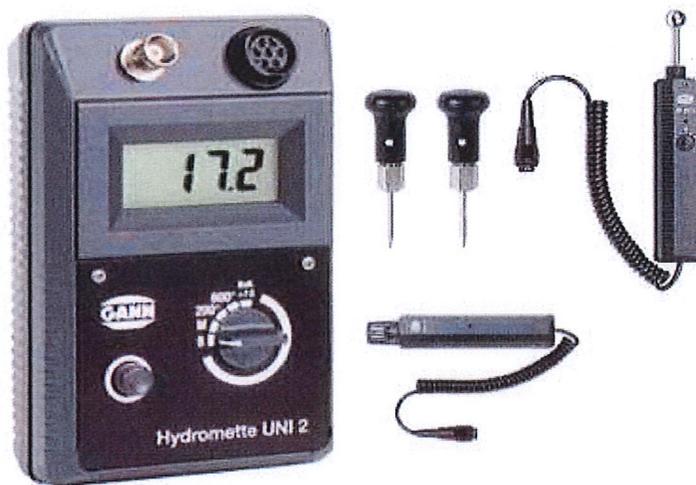
GANN HYDROMETER B50 UNI 2

THE FIRST TEST CONDUCTED BY THE RENODRY ENGINEER INVOLVES THE USE OF A GANN HYDROMETER B50 THAT MEASURES WALL CONDUCTIVITY (THE DEGREE TO WHICH A SPECIFIED MATERIAL CONDUCTS ELECTRICITY). A PROBE IS SET ON THE SURFACE OF THE STONE, MASONRY OR MORTAR AND GIVES A READING INDICATING THE PRESENCE OR ABSENCE OF MOISTURE. THE HIGHER THE READING, THE MORE MOISTURE IS LIKELY IN THE WALL. THIS TEST GIVES THE ENGINEER A STRONG INDICATION THAT THERE IS MOISTURE PRESENT IN THE WALLS.

READINGS ON THE GANN INSTRUMENT RANGE FROM 0, AN INDICATION OF NO MOISTURE, TO 200 THE EQUIVALENT OF TOTAL SATURATION. FOR PURPOSES OF REVEALING MASONRY WALL MOISTURE, READINGS LESS THAN 70 INDICATE NORMAL TO SLIGHTLY ABOVE NORMAL LEVELS OF MOISTURE PRESENT; READINGS ABOVE 70 DEMONSTRATE EXCESSIVE LEVELS OF MOISTURE; **READINGS IN EXCESS OF 100 INDICATE EXTREME MOISTURE LEVELS IN THE MASONRY.** AS A COMPARISON, THE HUMAN BODY, ON AVERAGE WILL READ AROUND 160.

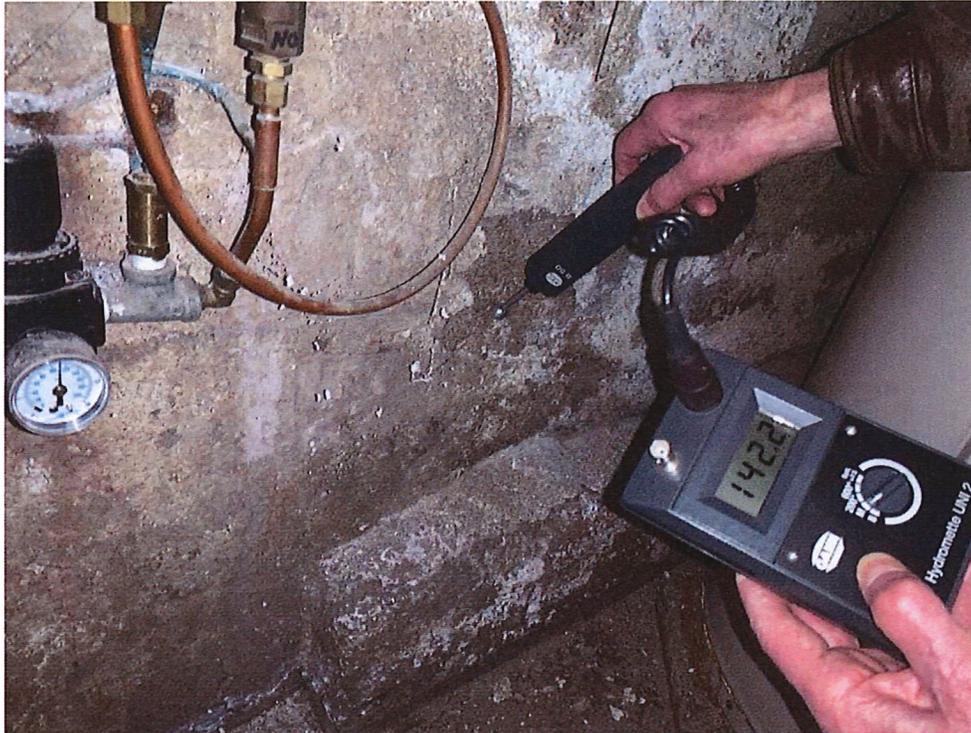
GANN HYDROMETER B50 UNI 2

WATER SATURATED MASONRY: MOISTURE LEVEL IN LOWER FOUNDATION WALL REACHING 142.2 – NEAR HUMAN BODY LEVELS OF MOISTURE

THE MASONRY WALLS OF BROOKINGS COUNTY COURTHOUSE HAVE MOISTURE TRAPPED IN THE INNER WALLS. RENODRY'S PRELIMINARY TESTS WITH THE GANN HYDROMETER INDICATED MANY OF THE EXTERIOR AND INTERIOR WALLS THAT COULD BE ACCESSED, HAD READINGS WELL OVER 100 SHOWING THE WALLS ARE BEING ERODED BY RISING DAMP.

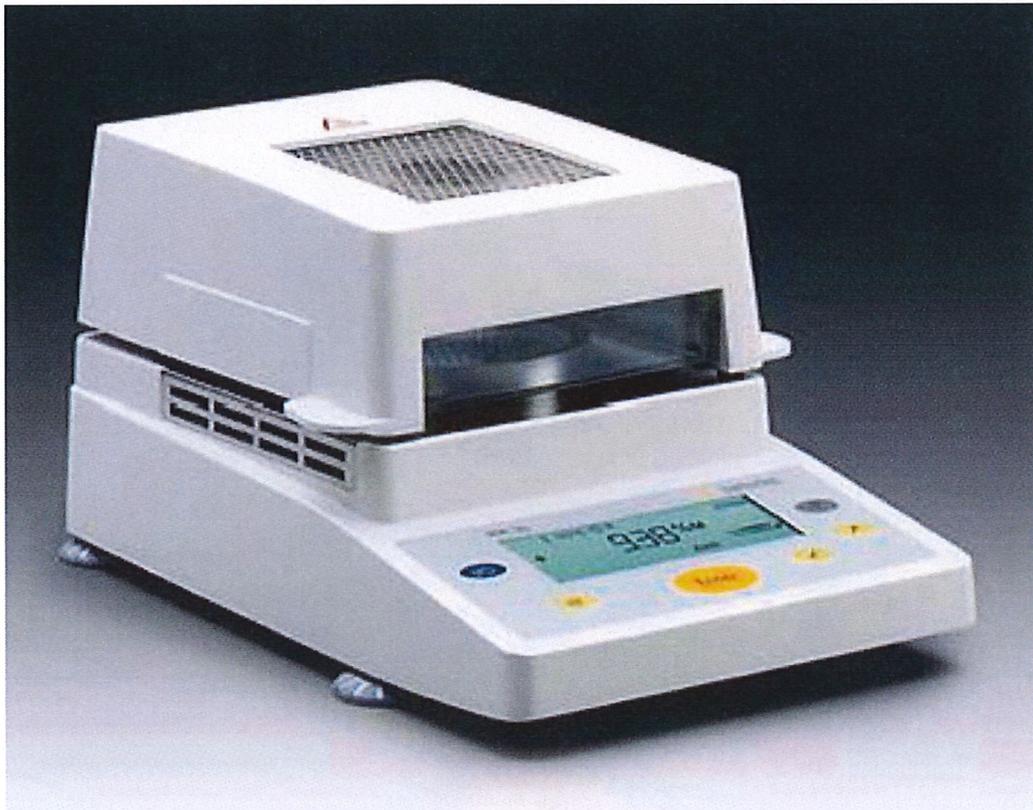
USING THE INTERNATIONAL STANDARD FOR DETERMINING MASONRY WALL MOISTURE – THE GRAVIMETRIC METHOD-- RENODRY WILL UTILIZE A SARTORIUS MA35 MOISTURE ANALYZER TO WEIGH EACH MASONRY SAMPLE, DRY IT AT 105 DEGREES C, AND THEN RE-WEIGH THE SAMPLE, THUS DETERMINING THE EXACT WEIGHT % MOISTURE OF THE MASONRY WALLS.

EXAMPLE OF MASONRY CORE SAMPLE BEING WEIGHED,
DRIED OUT AND RE-WEIGHED FOR MOISTURE ANALYSIS.

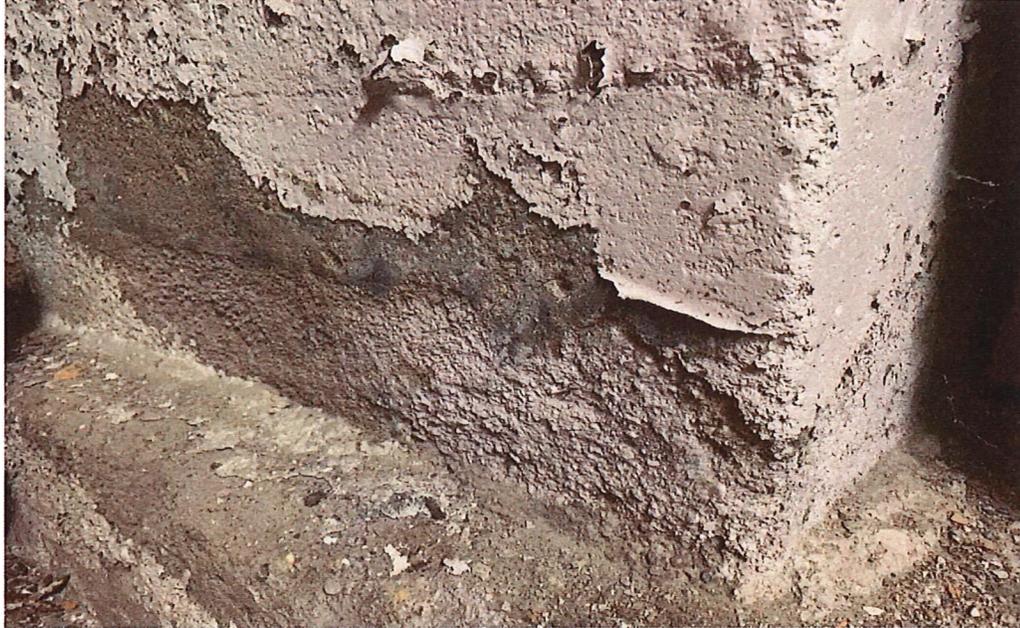
*MASONRY WALL DISINTEGRATING FROM EXCESSIVE SALT PENETRATION.
PAINT PEELING FROM SALT BEING PRESSED TO THE SURFACE.*

A RENODRY DEHYDRATION SYSTEM SHOULD BE INSTALLED IN BROOKINGS COUNTY COURTHOUSE TO PERMANENTLY HANDLE THE RISING DAMP PROBLEM AND DRY OUT THE FOUNDATION WALLS.

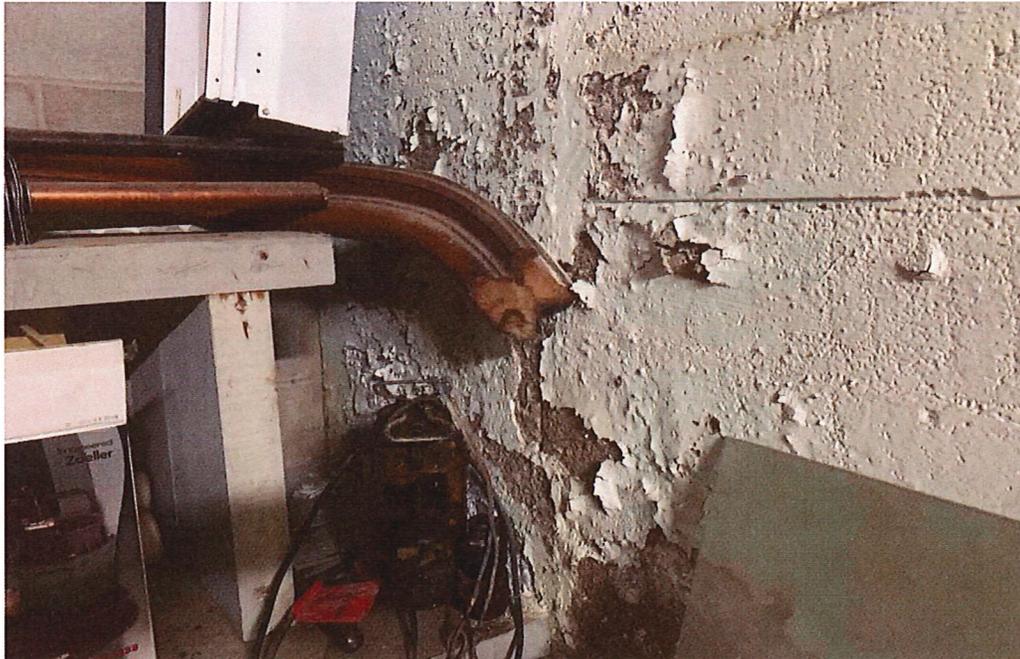
*FREE-STANDING INTERIOR WALL SHOWING BUBBLING, PEELING PAINT.
MASONRY BEGINNING TO SPALL FROM ADVANCING RISING DAMP.*

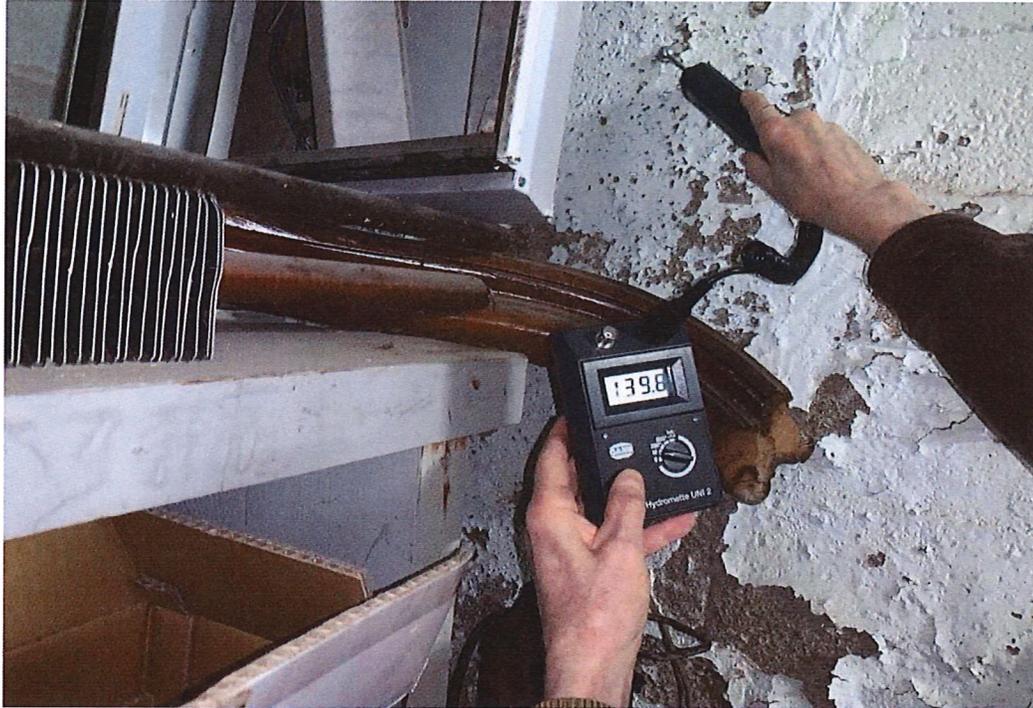
EXTREME HYDROMETER READINGS OF 139.8 FROM MOISTURE CLIMBING UP MASONRY WALL. MASONRY FOUNDATION BEING COMPROMISED BY SALTS

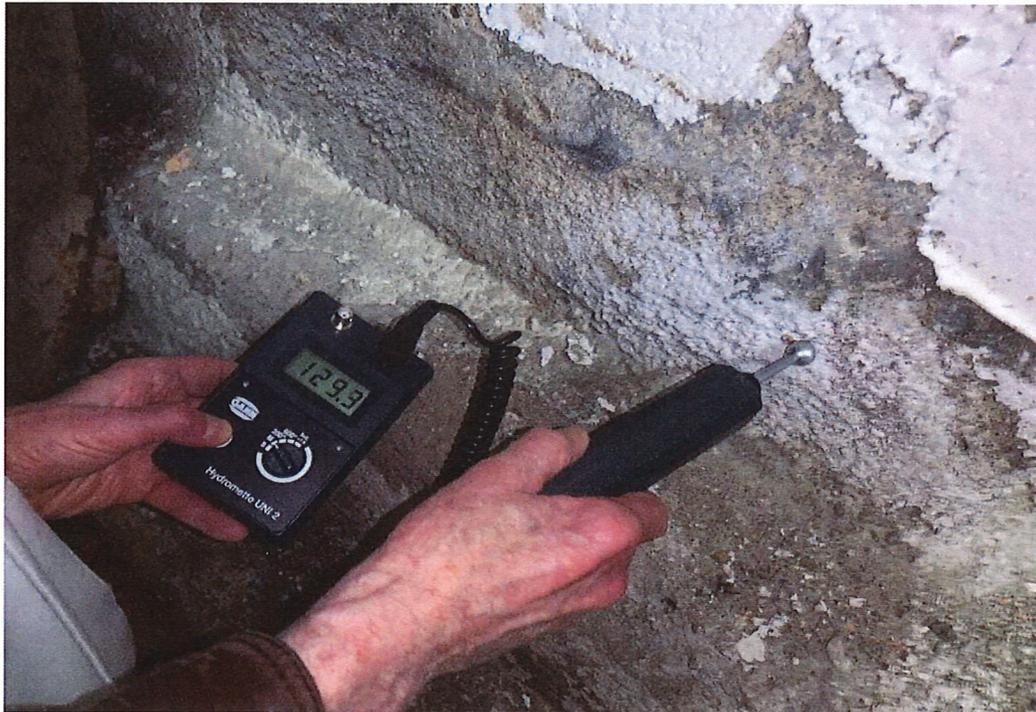
INTERIOR MASONRY WALL – MOISTURE RISING ABOVE GROUND LEVEL RESULTING FROM RISING DAMP. SALT NESTS THROUGHOUT WALL STRUCTURE.

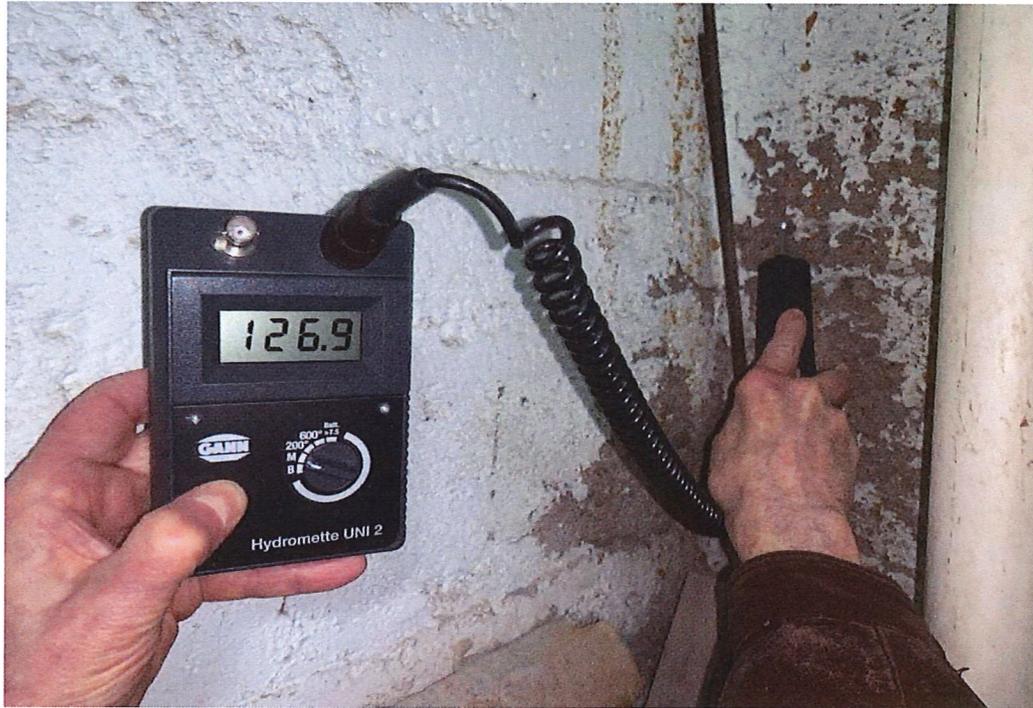
A VERY HIGH MOISTURE READING 5 FEET UP FREE-STANDING WALL.
MASONRY SPALLING, PAINT PEELING, MOISTURE RISING WITH SALTS.

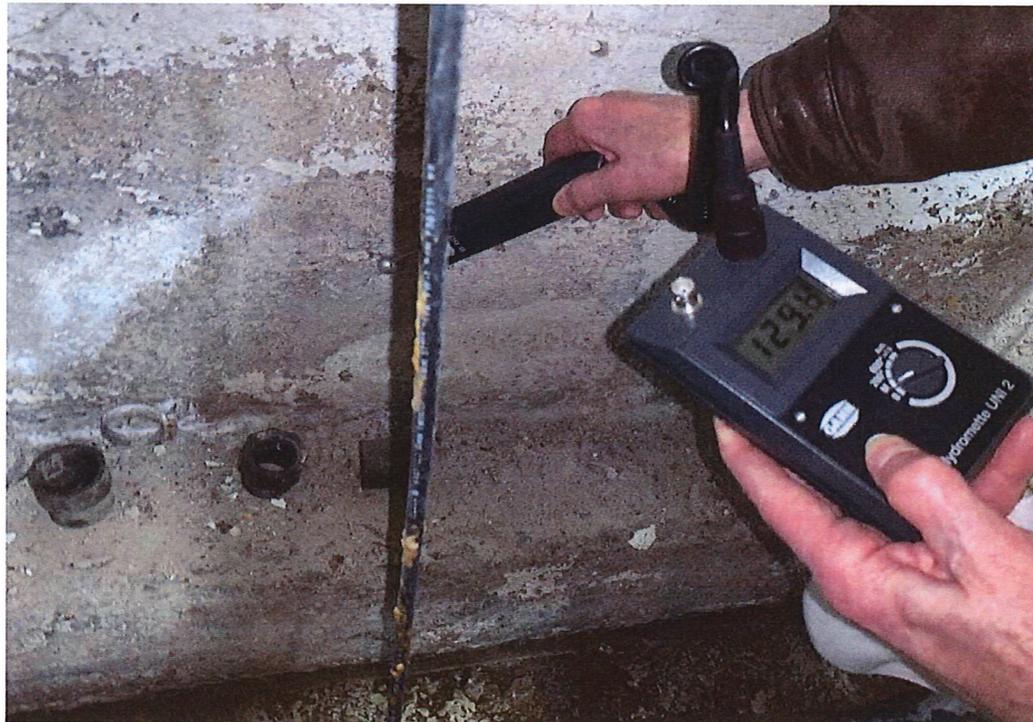
THE SATURATING EFFECT OF RISING DAMP WHEN IN THE ADVANCED STAGES,
NOTE DISINTEGRATED MASONRY ALONG BASE OF WALL.

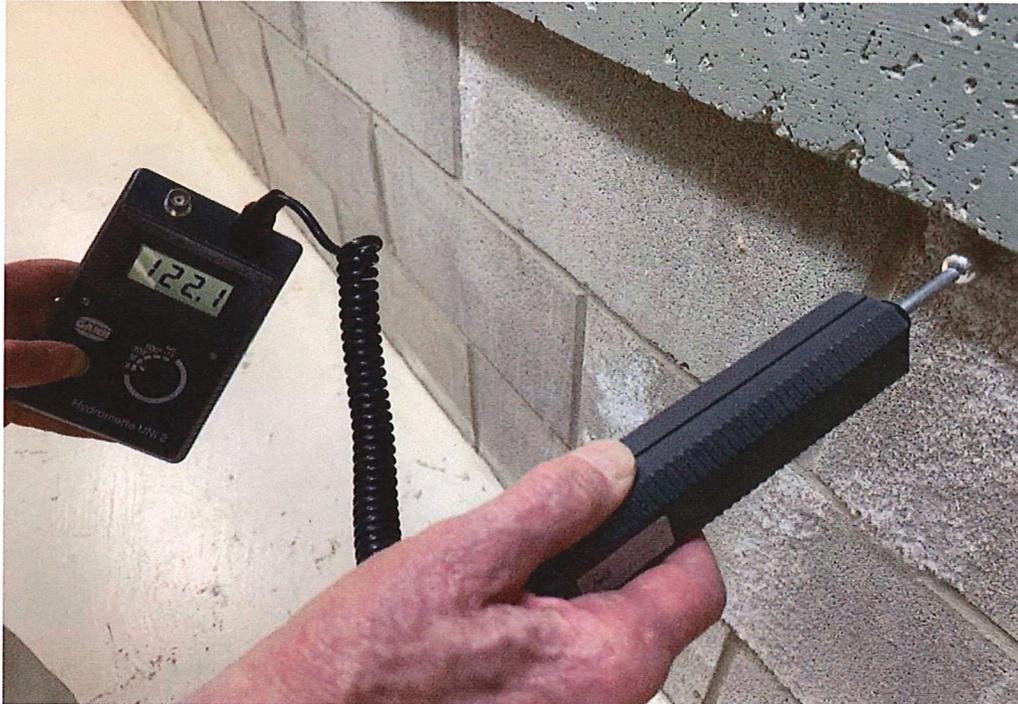
INTERIOR FREE-STANDING BLOCK WALL SHOWING MOISTURE LEVELS ARE VERY HIGH FROM RISING DAMP WITH SALT NESTS FORMING.

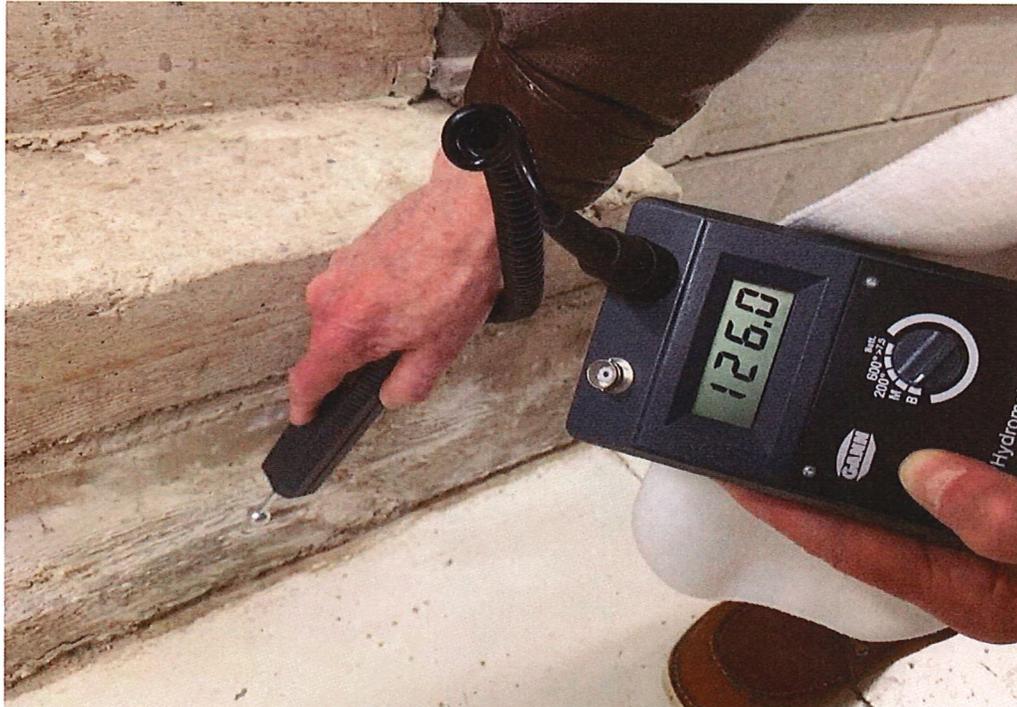
SUPPORT COLUMN IN COUNTY RECORDS VAULT AREA WITH EXCESSIVE MOISTURE READINGS FROM RISING MOISTURE.

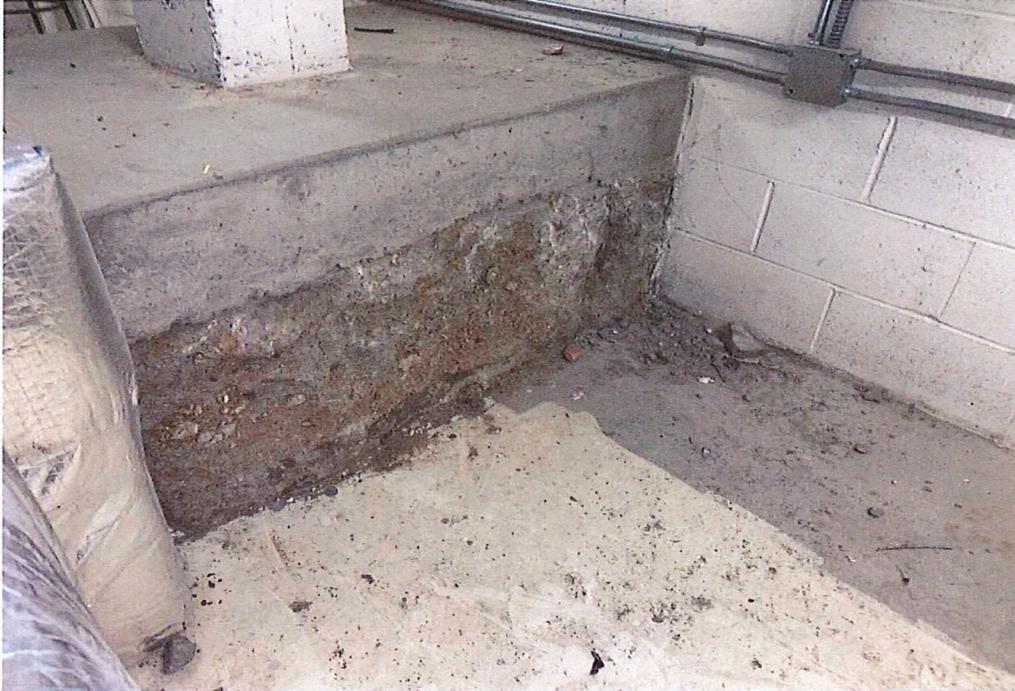
SUPPORT COLUMN FOUNDATION WITH NEW CONCRETE SLAB COVERING THE DISINTEGRATING FOUNDATION.

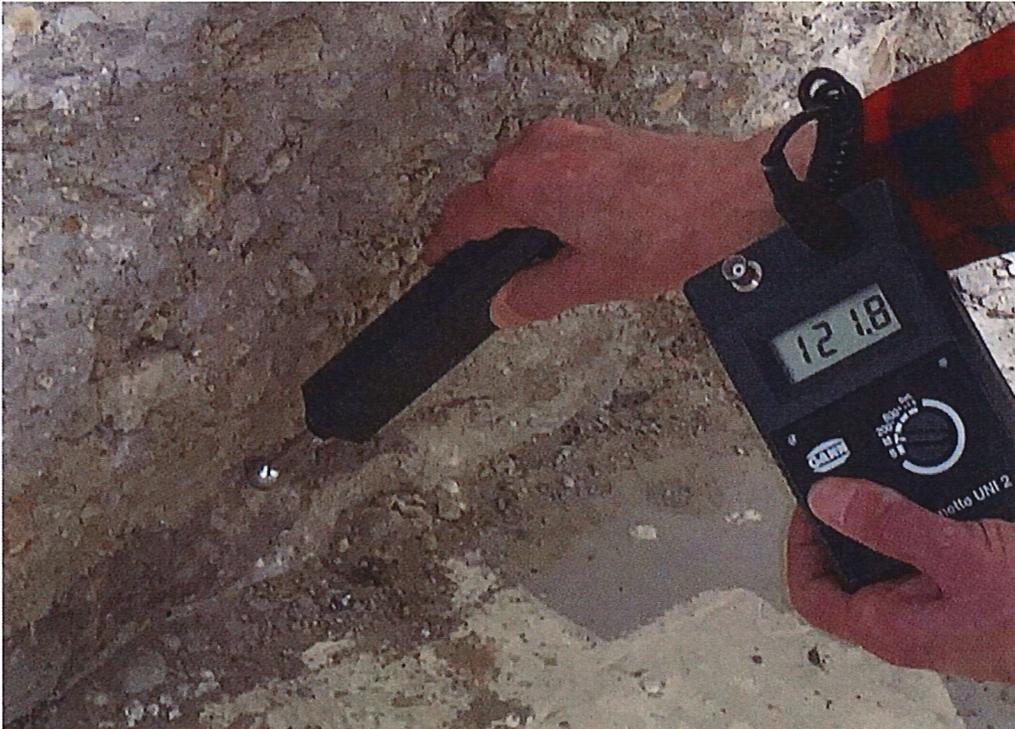
HYDROMETER READING OF COLUMN FOUNDATION IN ABOVE PHOTO. EXCESSIVE SALT AND MOISTURE COMPROMISING COLUMN FOUNDATION.

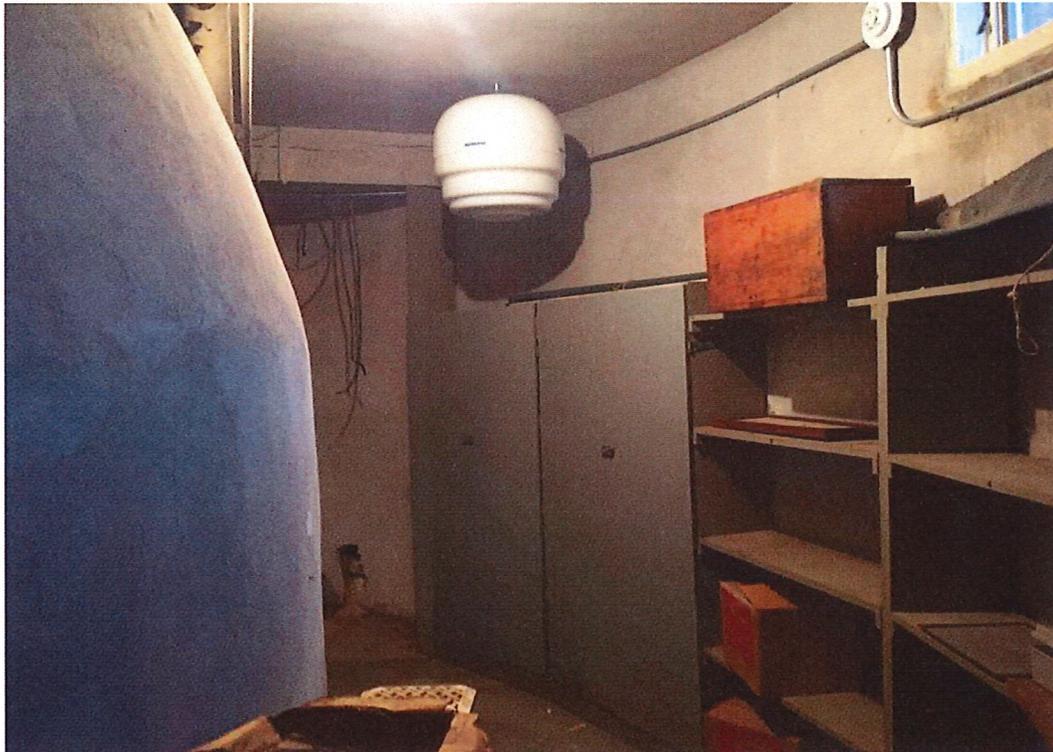
EXAMPLE OF THE LARGEST RENODRY TAKEN AT THE OLDEST OBSERVATORY IN MINNESOTA. LOCATION: NORTHFIELD

THE RENODRY WILL EFFECTIVELY ELIMINATE ALL RISING DAMP FROM THE COURTHOUSE EVEN THOUGH THE STRUCTURE HAS MULTIPLE THICK WALLS TO DEHYDRATE. THE APPROXIMATE GROUND LEVEL SQUARE FOOTAGE OF THE COURTHOUSE IS 6,600.
